Platt, S, Erandi, I, Jayasinghe, C, Jayasinghe, T, Maskell, D, Ranasinghe, G & Walker, P 2020, 'Improving the lateral load resistance of vernacular masonry walls subject to flooding', *Proceedings of Institution of Civil Engineers: Construction Materials*. <https://doi.org/10.1680/jcoma.20.00004>

Improving the lateral load resistance of vernacular masonry walls subject to flooding

Abstract

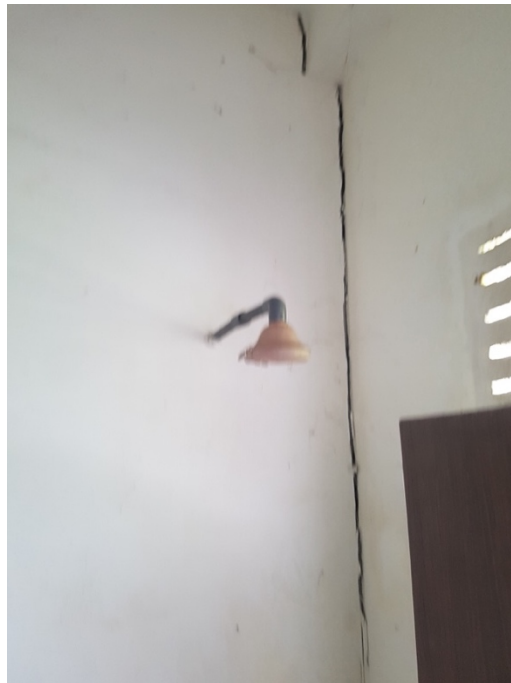
Figure 2. Cracking between adjoining walls

In 83% of buildings surveyed in the flood affected regions, the flood waters reached at least 2 metres high. Damage to masonry walls and buildings from the flooding characterised during the field survey included: cracking/failure between adjoining walls (Figure 2); cracking along solid walls (Figure 3); cracking/failure around openings (Figure 4); and total wall collapse (Figure 5).

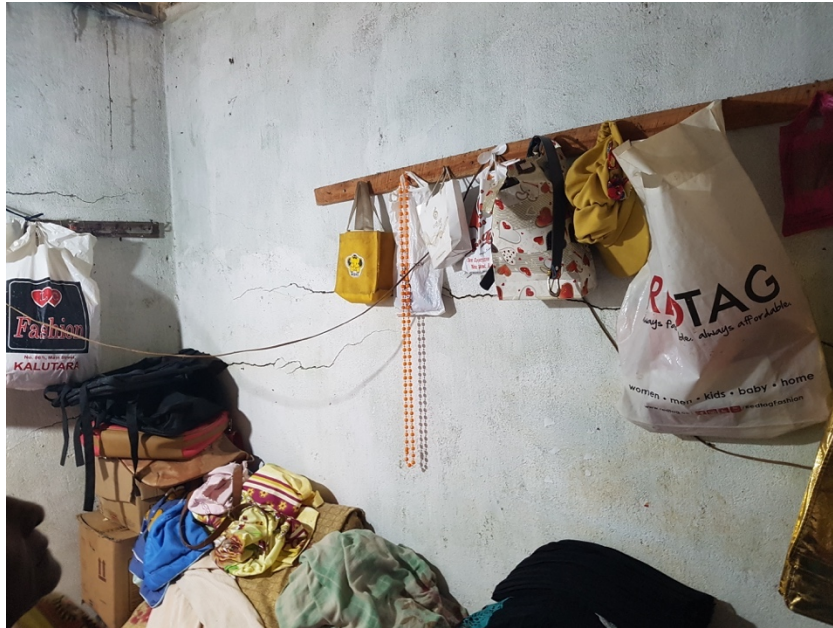
Figure 3. Cracking in solid wall

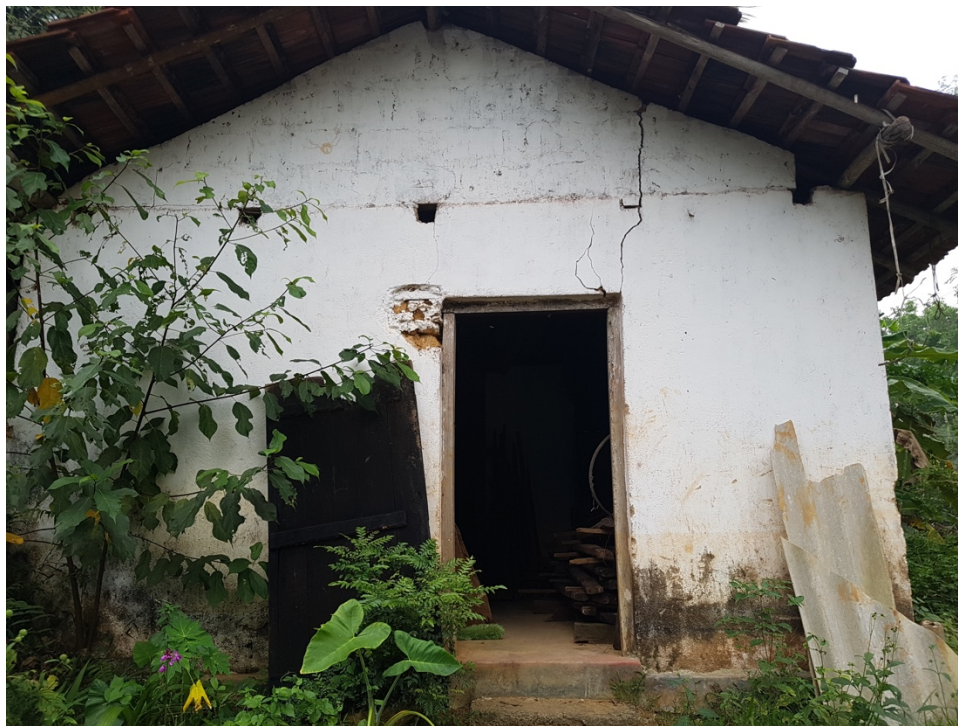
Figure 4. Cracking around opening

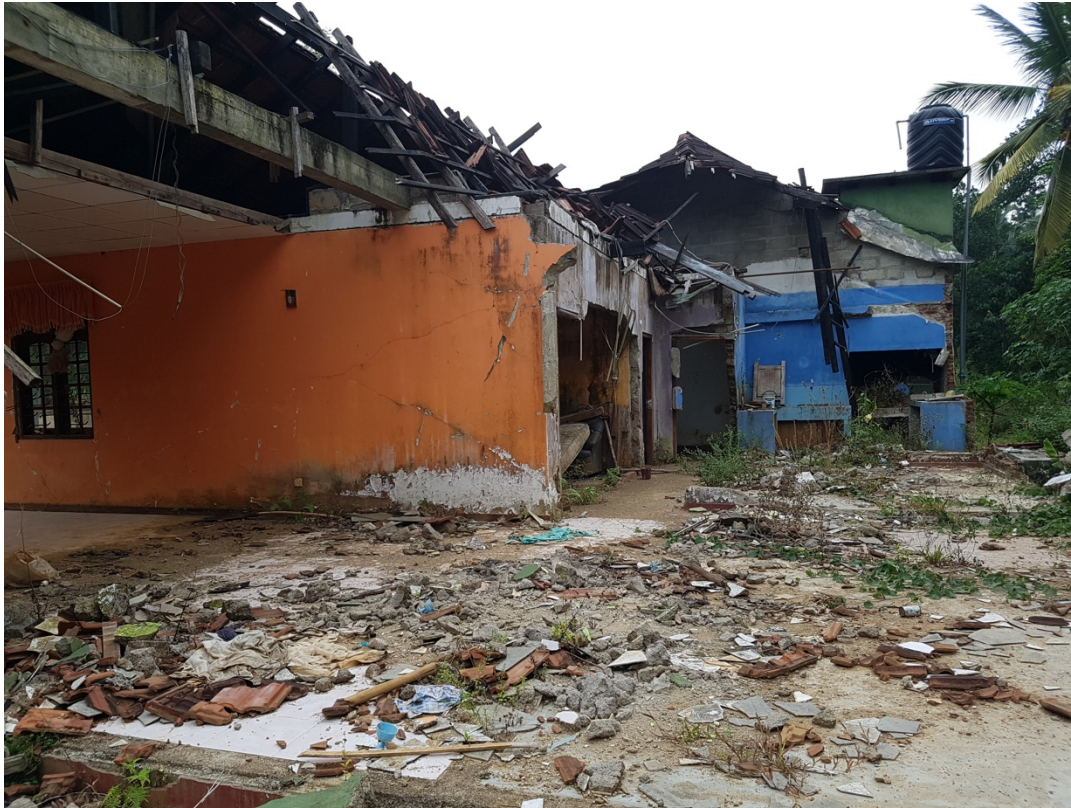
Figure 5. Total wall collapse

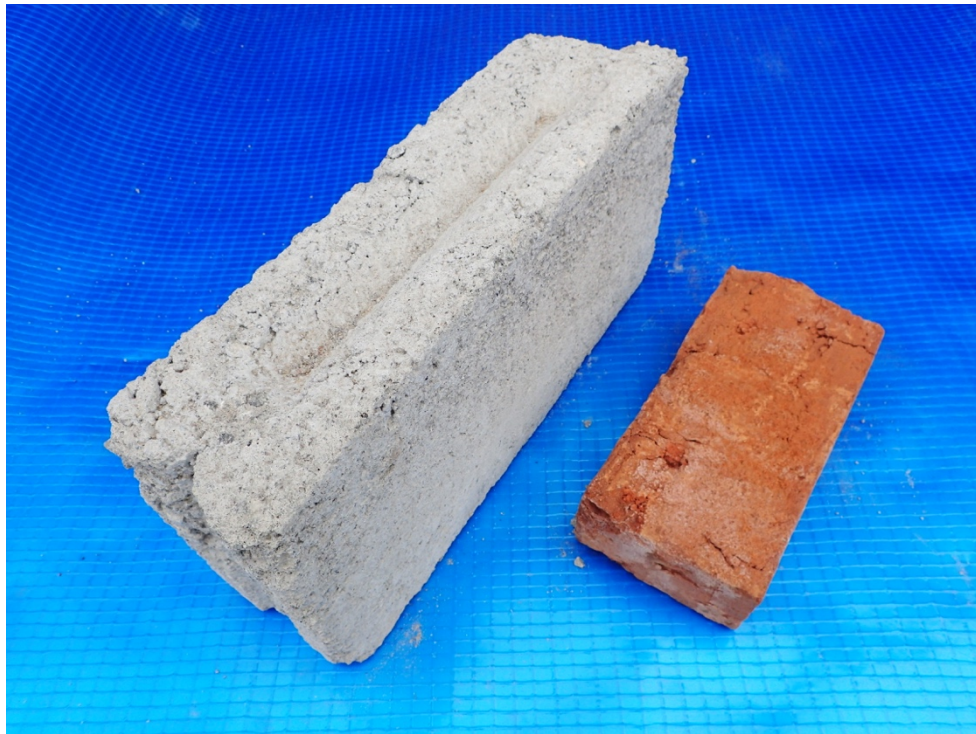
Figure 6. Masonry units

the constituents generally comprise cement, sand, and quarry dust. The nominal dimensions of the cement blocks were 400 mm (length) 100 mm (width) x 200 mm (height). The fired clay brick and cement blocks used are shown in Figure 6.

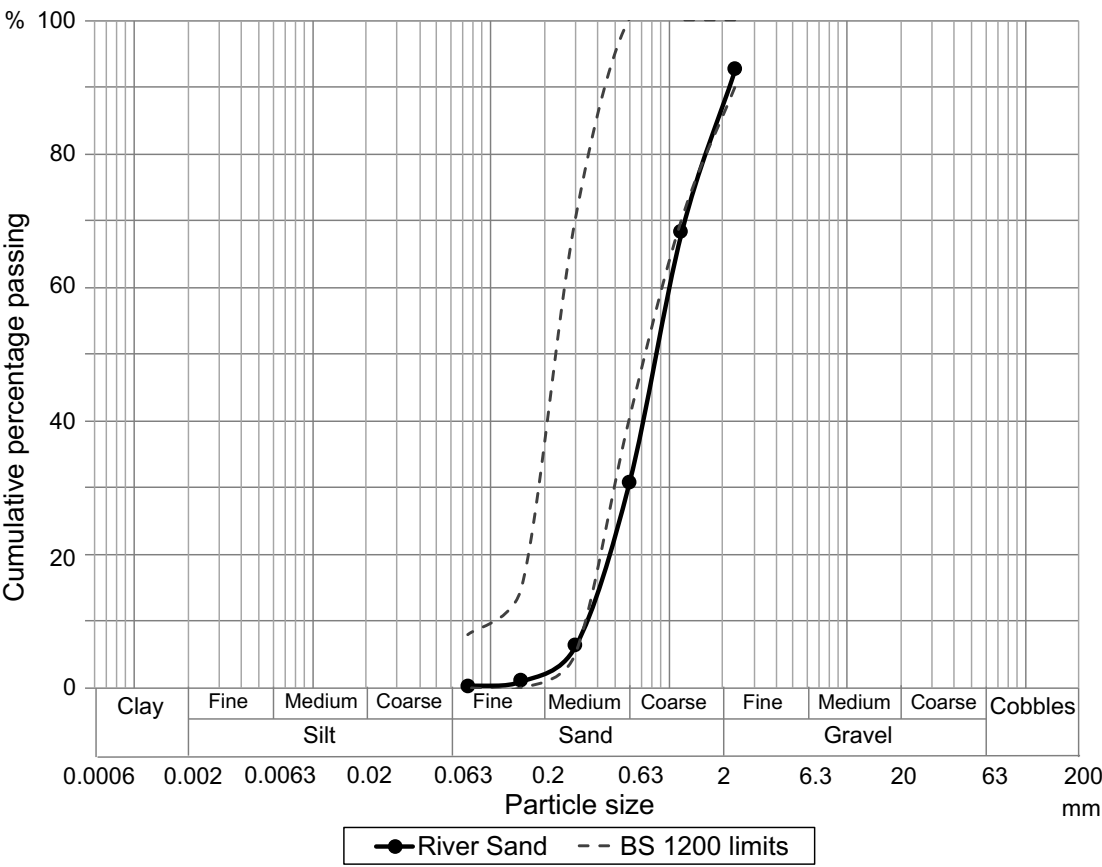
Figure 7. Sand composition related to BS1200 requirements

Masonry wall panels were built to determine the flexural and compressive strength of the cement block and fired clay brick masonry using representative materials. The wall panels were built using the same mortar mix commonly used in Sri Lankan practice, a 1:6 cement: sand mortar using Ordinary Portland Cement and a river sand fine aggregate. The sieve analysis results for the sand are shown in Figure 7.

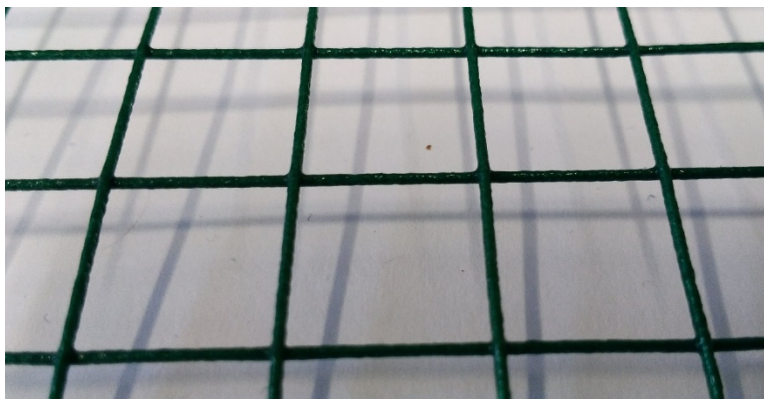
Figure 8. PVC coated welded wire mesh

191 A PVC coated galvanised mild steel wire mesh, (widely available from local hardware
192 stores and building merchants) was selected (Figure 8). The square mesh,
193 manufactured in Sri Lanka, is comprised of 0.81 mm diameter wires spaced at 12.5 mm
194 openings. Normally used as a lightweight material for a variety of domestic uses, it was
195 selected for its low cost, ease of handling, and readily availability throughout Sri Lanka.
196 Welded wire mesh products tend to be orthotropic due to their production process
197 where the longitudinal wires (machine direction - *md*) are under tension as the cross
198 wires (cross machine direction - *cmd*) are welded in place.

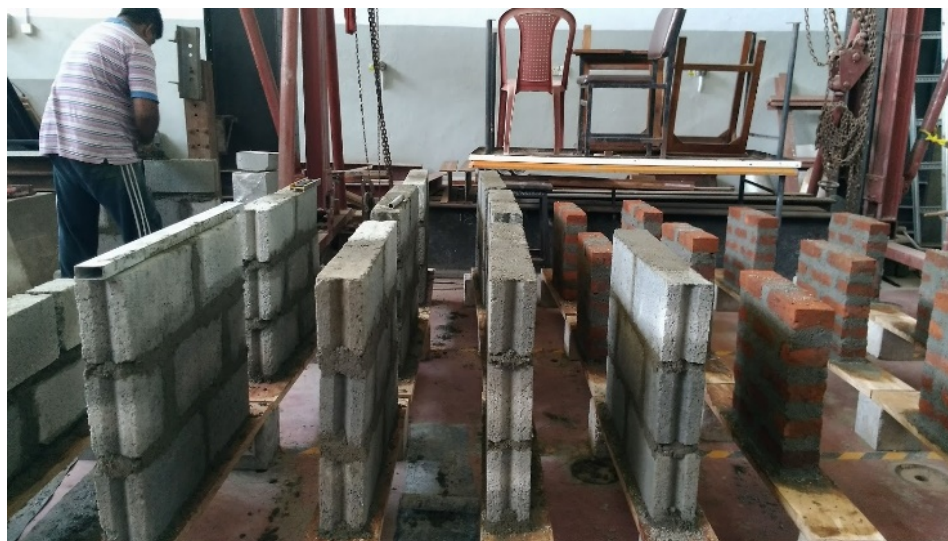
Figure 9. Masonry prism construction

264 Two unit wide stack bonded wall panels were built to establish the compressive strength
 265 of the cement block and fired clay brick masonry (Figure 9). The fired clay brick panels
 266 were five courses high, whilst the cement blocks were three units high.

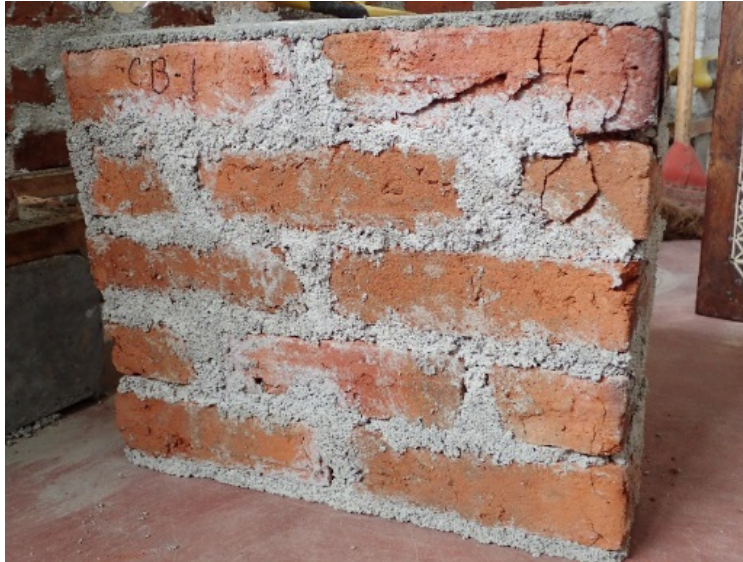
Figure 11. Brickwork prism failure in compression tests

The compressive strength properties of the cement blockwork and fired clay brickwork prisms are presented in Table 4. The average mortar compressive (f_m) and flexural (f_{mt}) strengths are also included. Tests were only completed under air-dry conditions. The characteristic compressive strength has been calculated in accordance with BS EN 1052-1:1999. Failure of the wall panels in compression was preceded by vertical cracking of masonry units prior crushing of the materials (Figure 11).

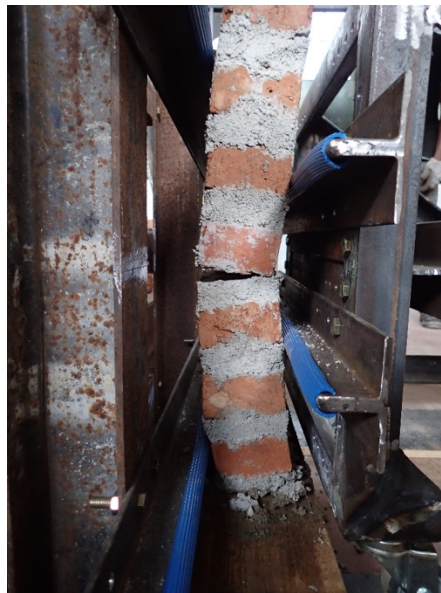
Figure 12. Parallel bed joint flexural test failure

The results for flexural strength parallel to bed joints are summarised in Table 5. The average mortar compressive (f_m) and flexural (f_{mt}) strengths are also included. A representative failure mode in testing is shown in Figure 12 with failures most commonly at the interface between the mortar and unit. Therefore, it is expected that the bond strengths are consistently lower than the flexural strengths of the mortar (Table 4). In

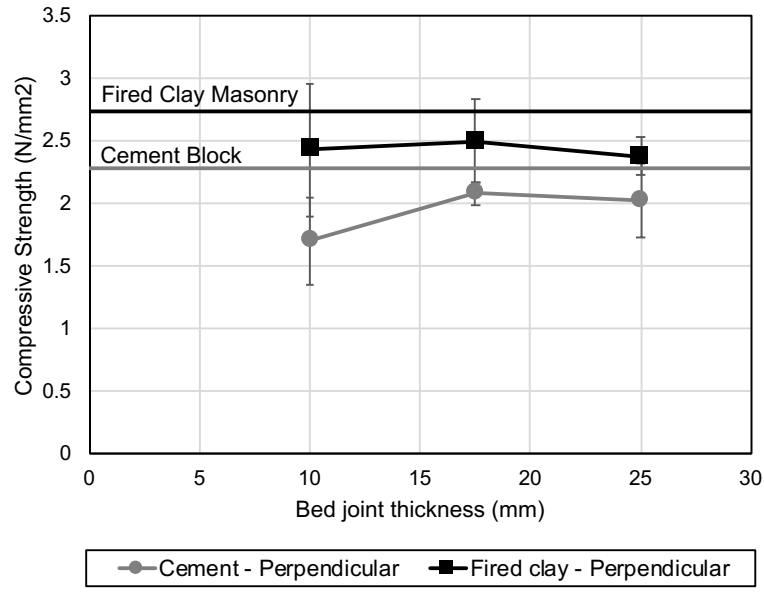
Figure 14. Influence of mortar thickness of compressive strength of masonry panels.

In general the compressive strength of masonry can be expected to decrease with increasing mortar joint thickness. Figure 14 (the error bars represent 95% confidence interval) shows that this behaviour has not been observed here. While there is an apparent peak in both compressive and flexural strength (Figure 14) at 17.5mm for all masonry units, there is no statistically significant difference, based on the two-sided 't-test' with a p-value of <0.05 , between the respective results for a given mortar thickness. The relative high strength of the mortar compared to the unit strengths is the most likely explanation.

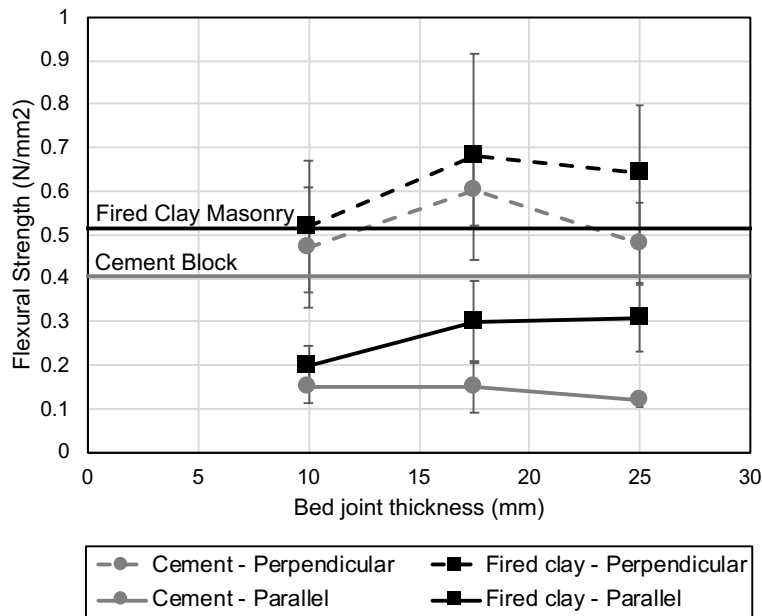
Figure 15. Influence of mortar thickness of flexural strength of masonry panels.

Whilst it would appear that the mortar thickness enhances the flexural strength properties of the masonry, similarly to compressive strength there is no statistically significant difference between the units and the flexural strength of the panels. However, the limiting factor, as observed in Figure 15 is the interface between the mortar and the masonry unit under parallel flexure which is the focus of the retrofitting.

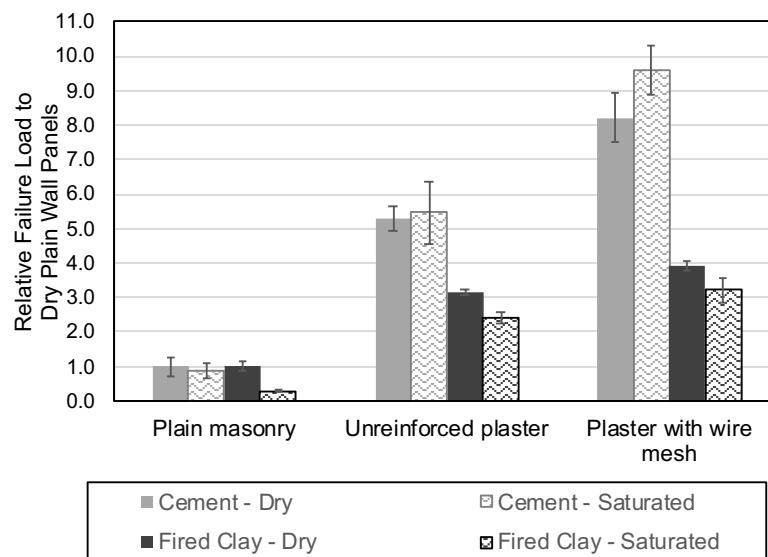
Figure 16. Relative Failure Loads of the wall panels compared to the Dry Plain Walls

The plaster coatings significantly increased flexural capacity compared to the plain masonry, with further 25% and 55% enhancement from the inclusion of the mesh reinforcement in cement block panels and fired clay masonry, as observed in Figure 16 (with error bars representing normalised confidence intervals) . The unreinforced plaster significantly increased the failure load, which is not solely attributed to the increased thickness of the material. The increase can be attributed to the additional tensile capacity provided by the plaster but also the continuity that the plaster provided over the mortar joints, the point of failure in the unplastered masonry panels. The additional enhancement in the panels with mesh reinforced plaster indicates that the mesh acted as a tensile reinforcement.
